10th IWA-ASPIRE CONFERENCE
AND WATER NEW ZEALAND
CONFERENCE & EXPO
Christchurch Ōtautahi
29 September - 3 October 2025

EMBRACING VIGILANCE

Richard Slight, Dora Luo

INTRODUCTION

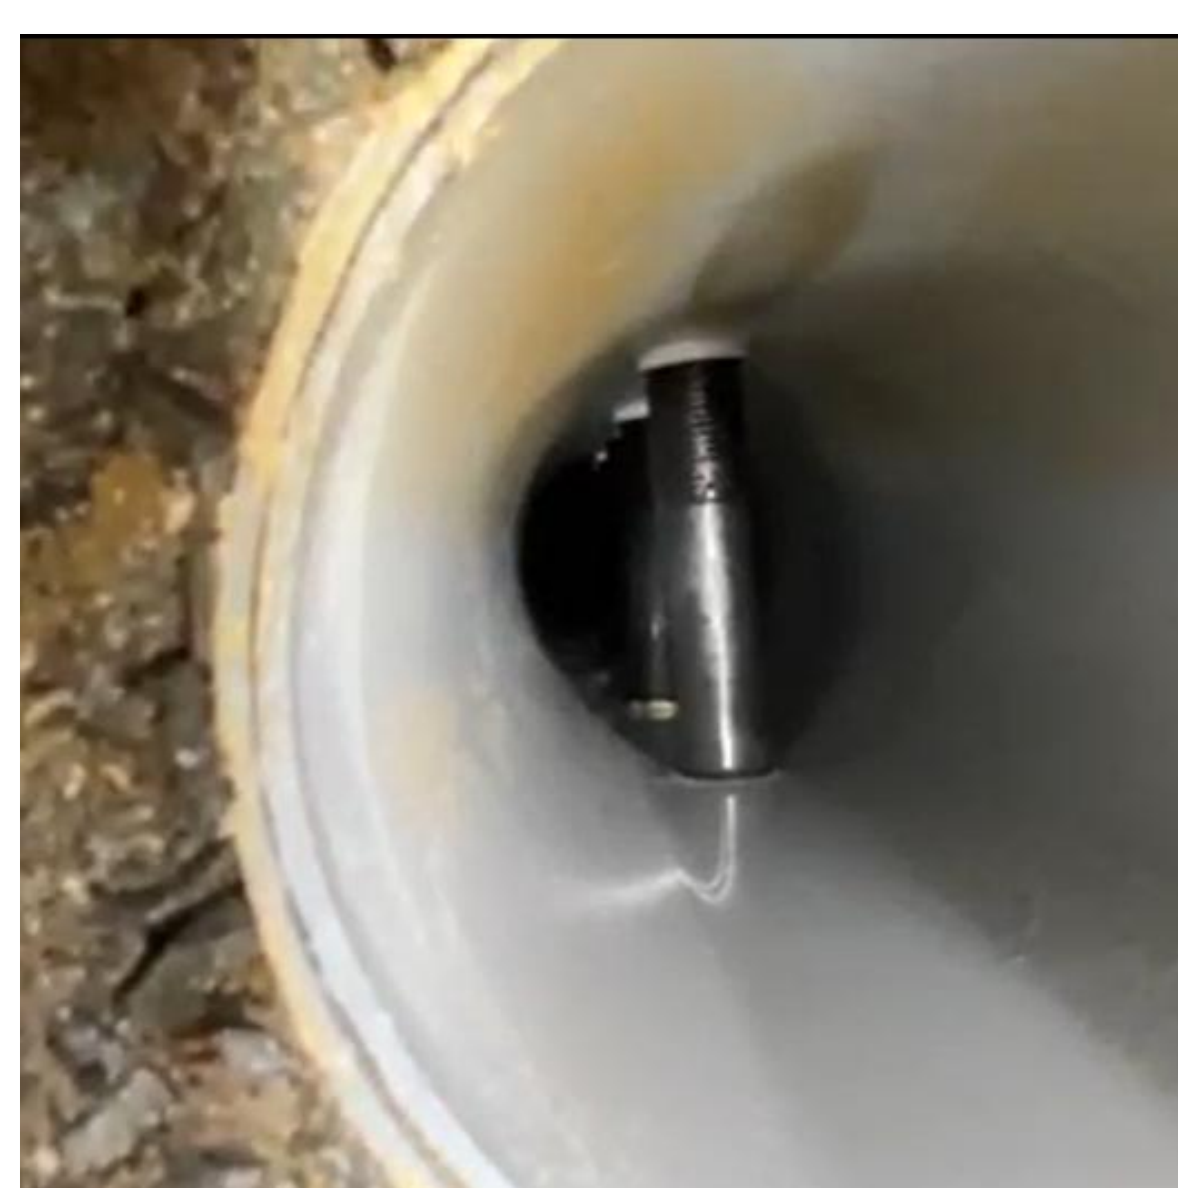
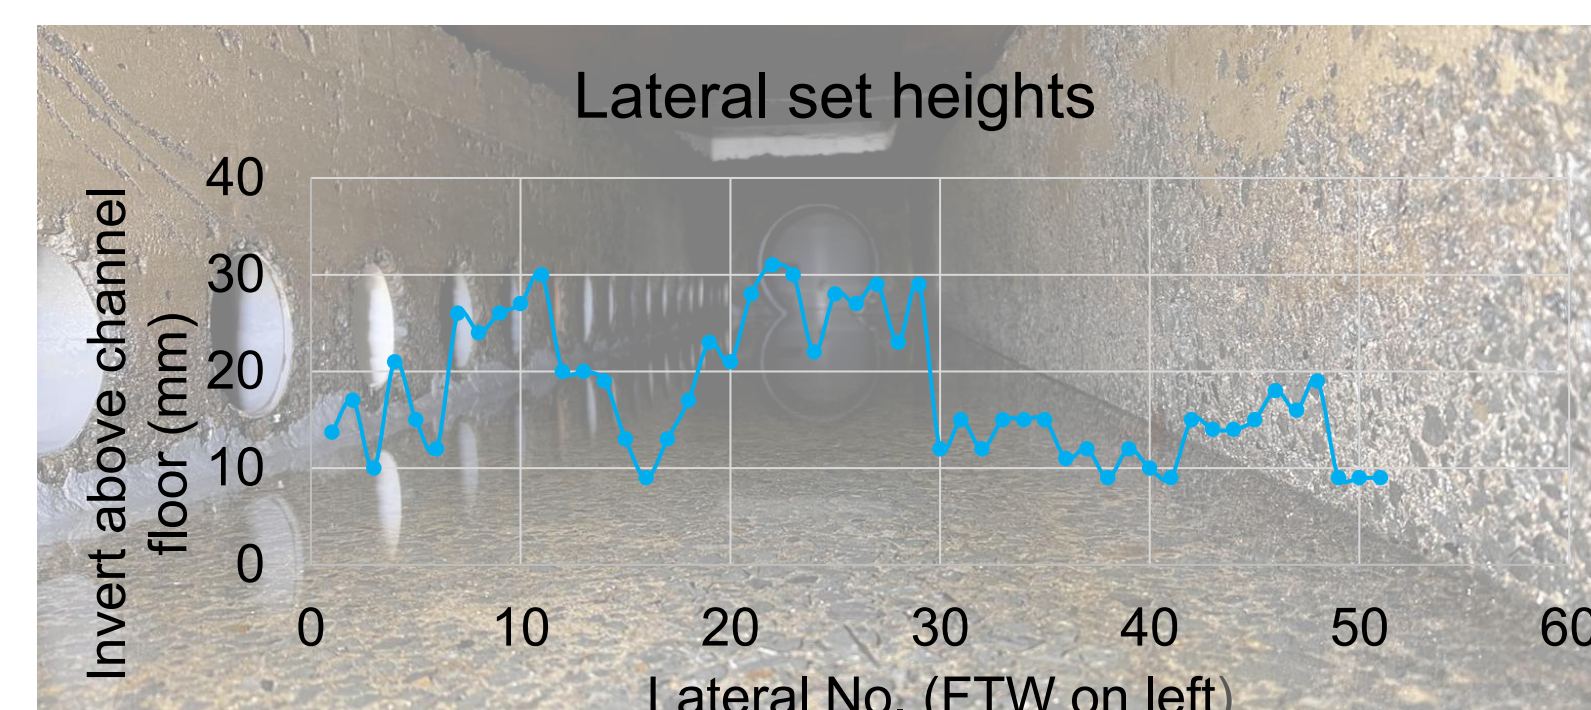
Construction Faults

- Laterals set at different heights in the filter floor
- Nozzle depth into pipe varies based on lateral height

- The existing nozzles were cleaned and reinstated
- Nozzles stems were each checked and trimmed to ensure clearance to the invert of the lateral
- Filter media was replaced with new dual combination to prevent sand migration
- Methodologies established for future works based on the lessons learnt
- QA process established for individual work packages

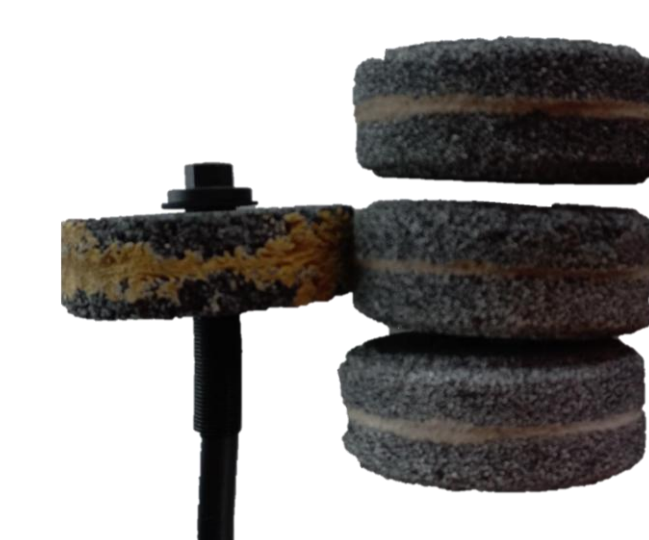
Supplier Fault

- Installed ceramic nozzles were 7 mm thinner than previous
