10th IWA-ASPIRE CONFERENCE
AND WATER NEW ZEALAND
CONFERENCE & EXPO
Christchurch Ōtautahi
29 September - 3 October 2025

EMBRACING VIGILANCE

Richard Slight, Dora Luo

INTRODUCTION

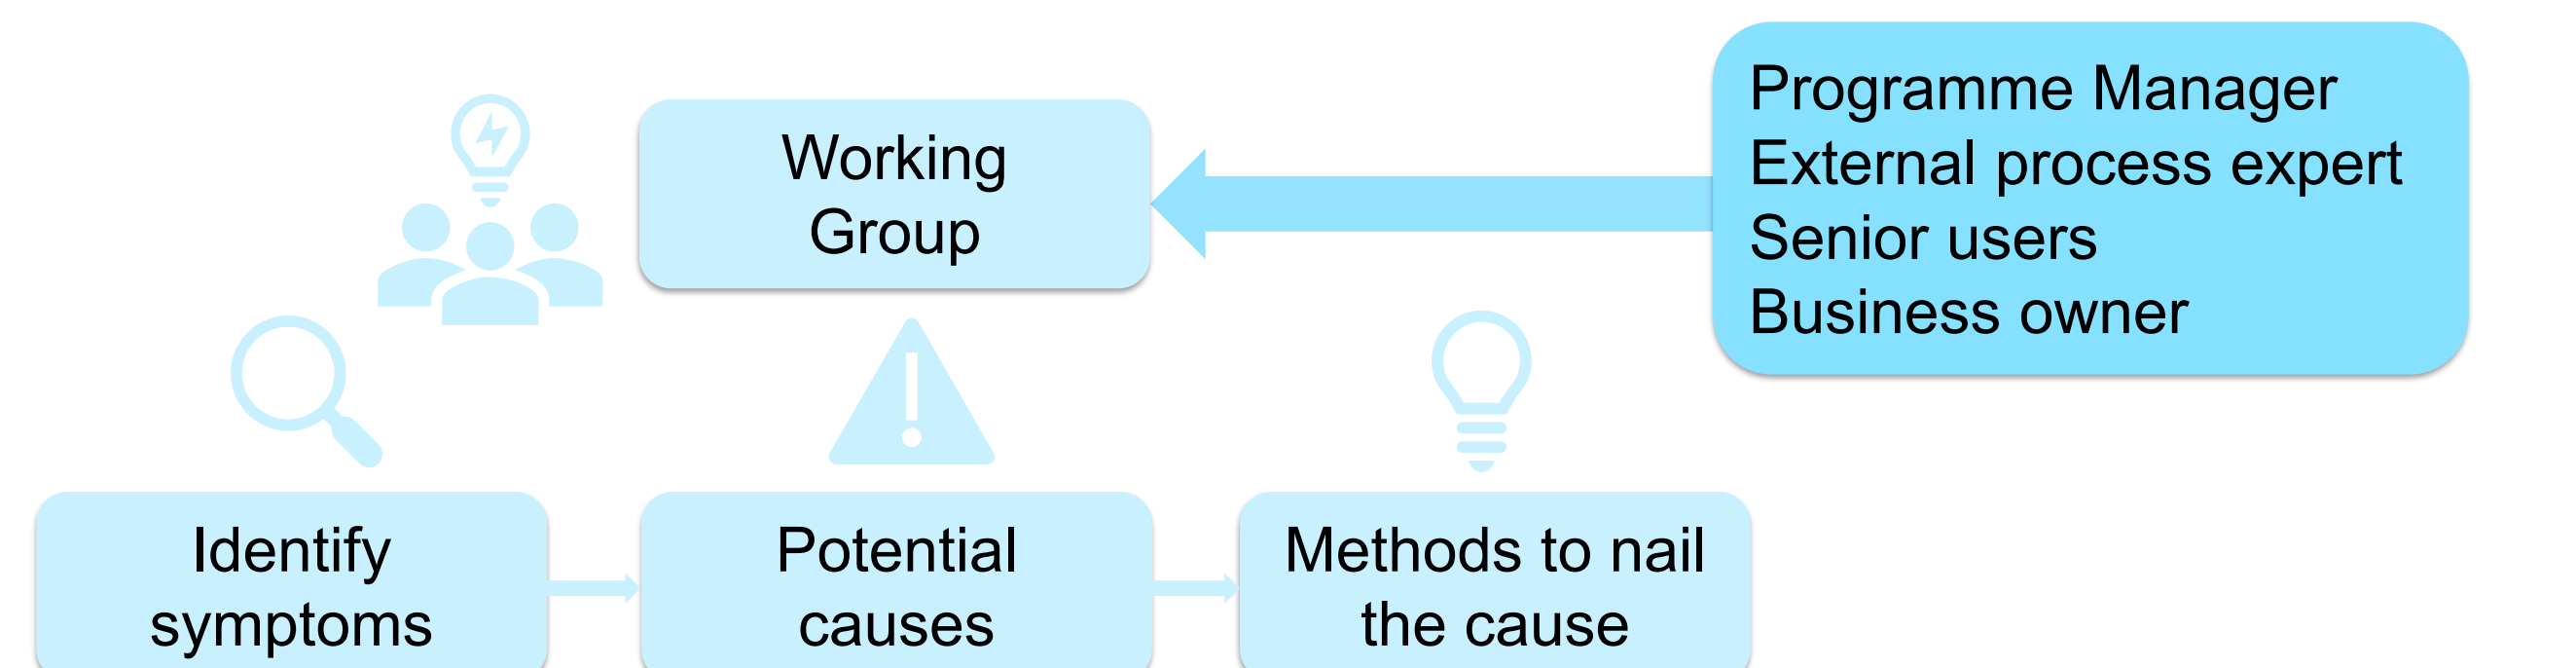
METHODS

- High Backwash Pressure
- Short Filter Run Time
- Low backwash flow
- High clean bed head loss
- Uneven flow distribution

- Valve Failure
- Plenum blockage
- Nozzles & Stems
- Air lock
- Finer media
- Laterals blockage

- Valve performance investigation
- CCTV Plenum
- Visual observations of media fluidisation
- Pilot filter comparisons
- Check nozzles / compare performance
- Breather/manometer pipe on plenum
- Measure head loss in situ from the base of the media
- In situ media grading comparisons
- Relocate media to performing filter and check change in head loss

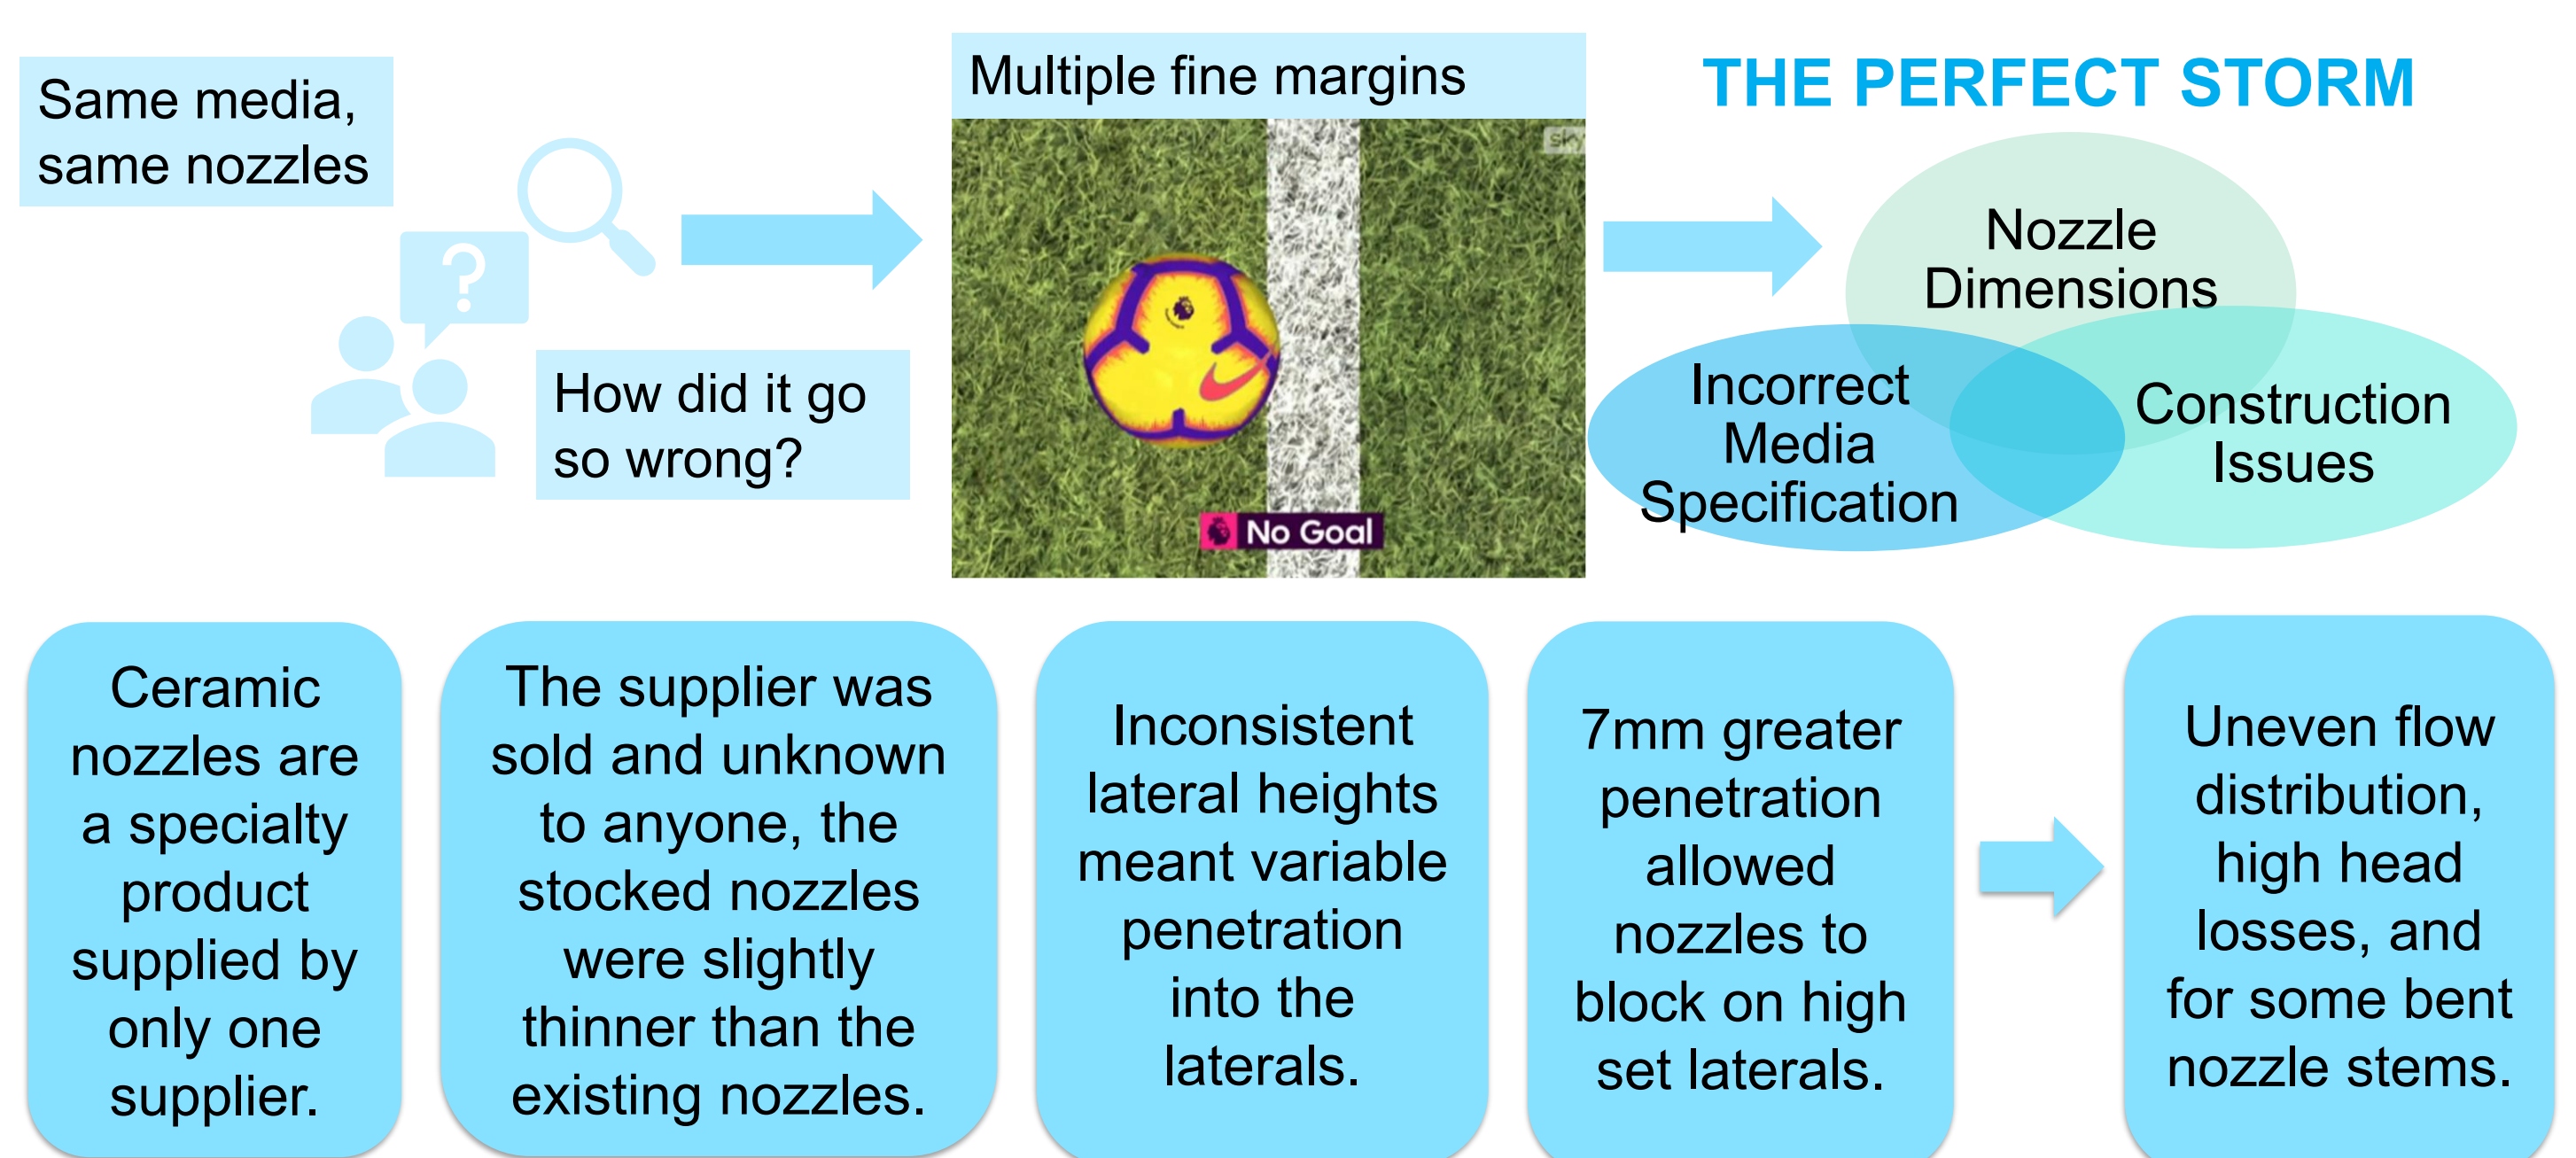
DISCUSSION

The media This was the first filter with a complete media replacement to PCDM (0.3 - 0.6mm) sand and 0.6 - 1.2 mm silicon sponge (expanded pumice). It was discovered through media sampling and pilot filter runs that the smallest sand grains migrated to the top layer, filling voids and creating a fine top layer that restricted flow. Prior to this, filters had a larger sponge grade (no longer available) so void spaces were much larger and head losses therefore lower.

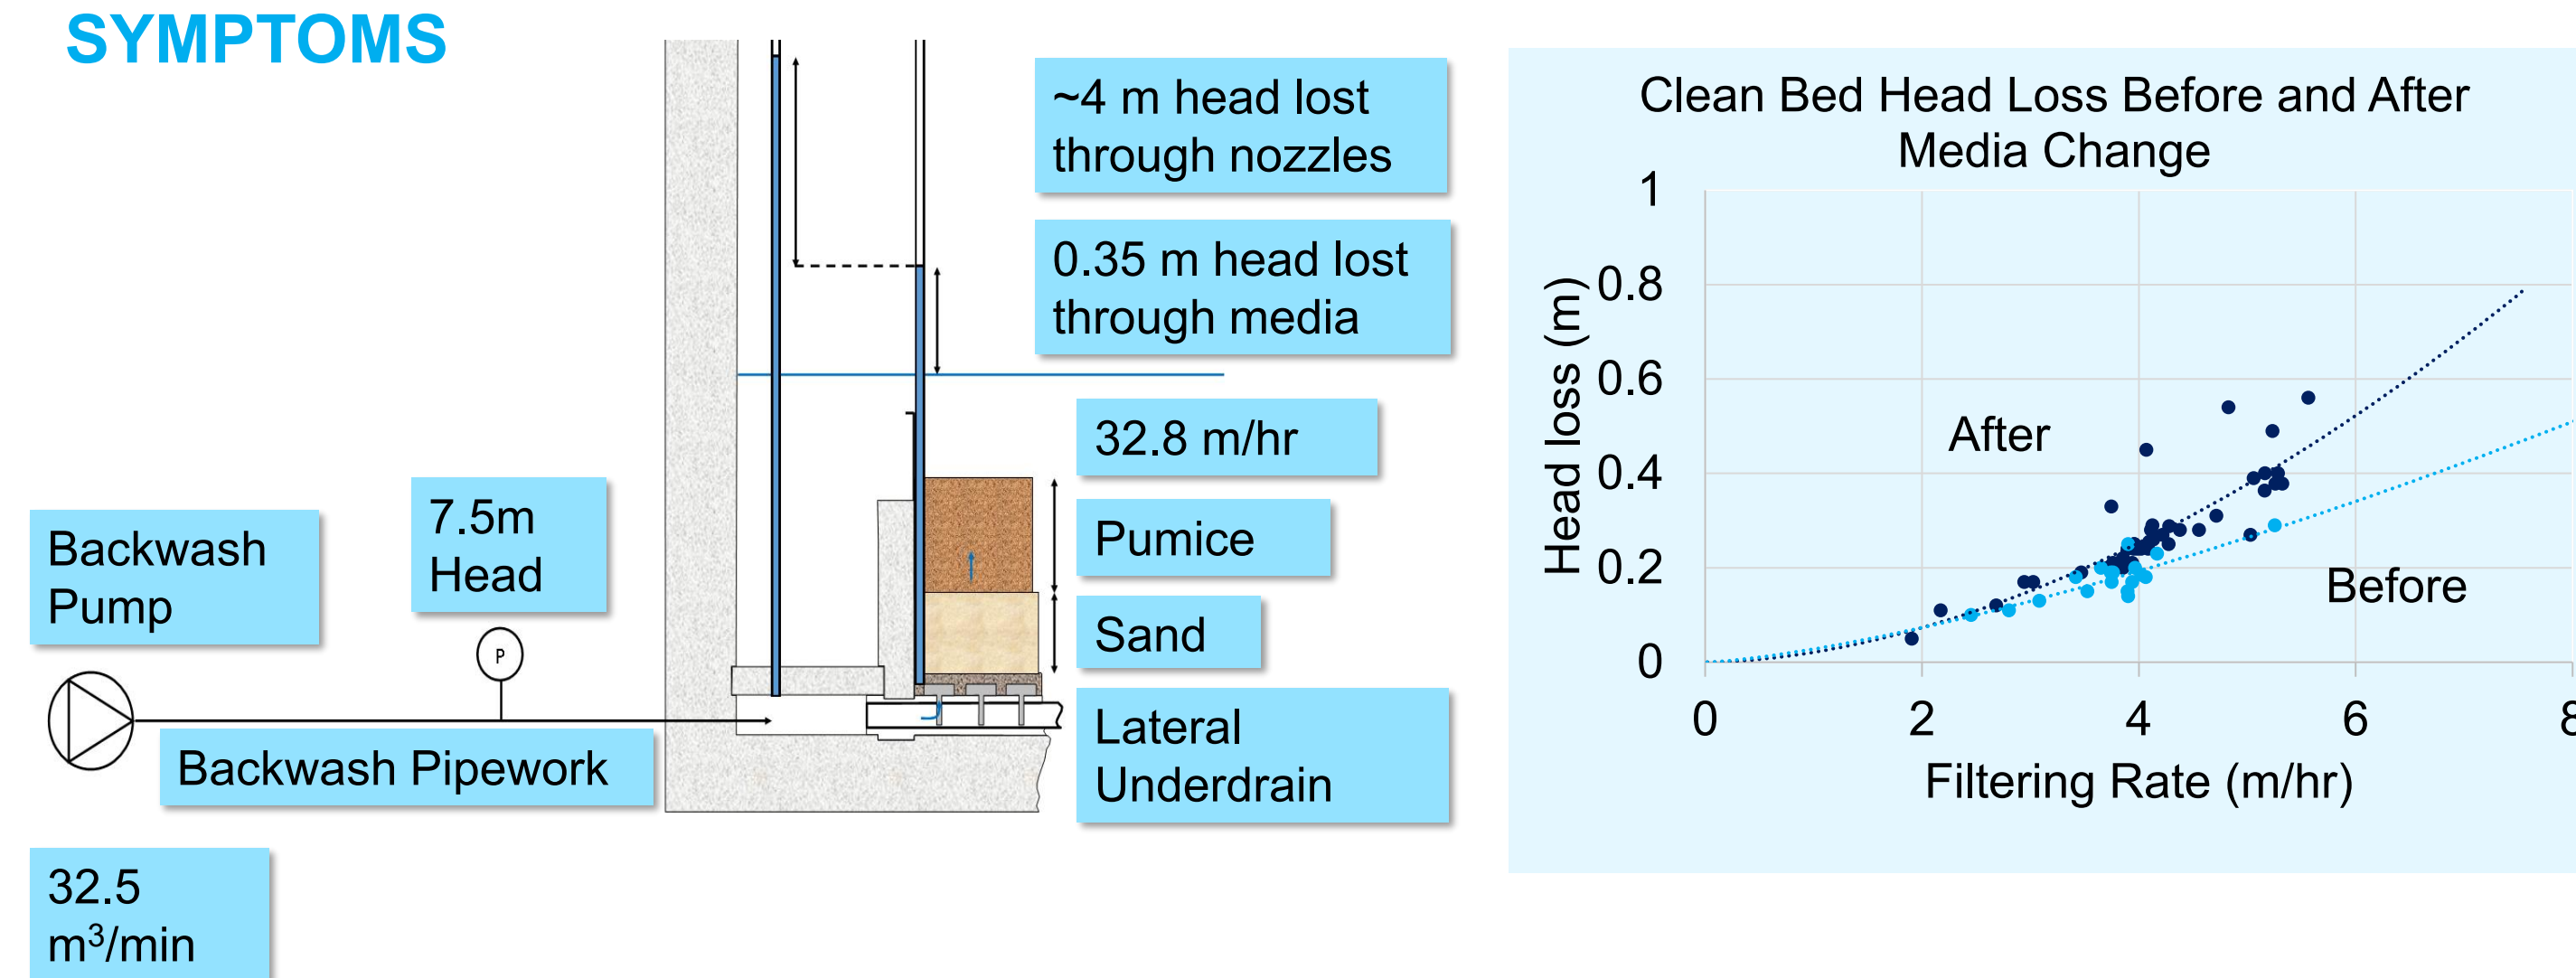
SYMPTOMS

Filter #1 is one of 10 rapid gravity filters using a dual media design of expanded pumice and fine sand. Filter #1 media and ceramic nozzles were replaced in October 2022. In January 2022, higher backwash pressure and shorter run times were observed and water production volumes reduced.

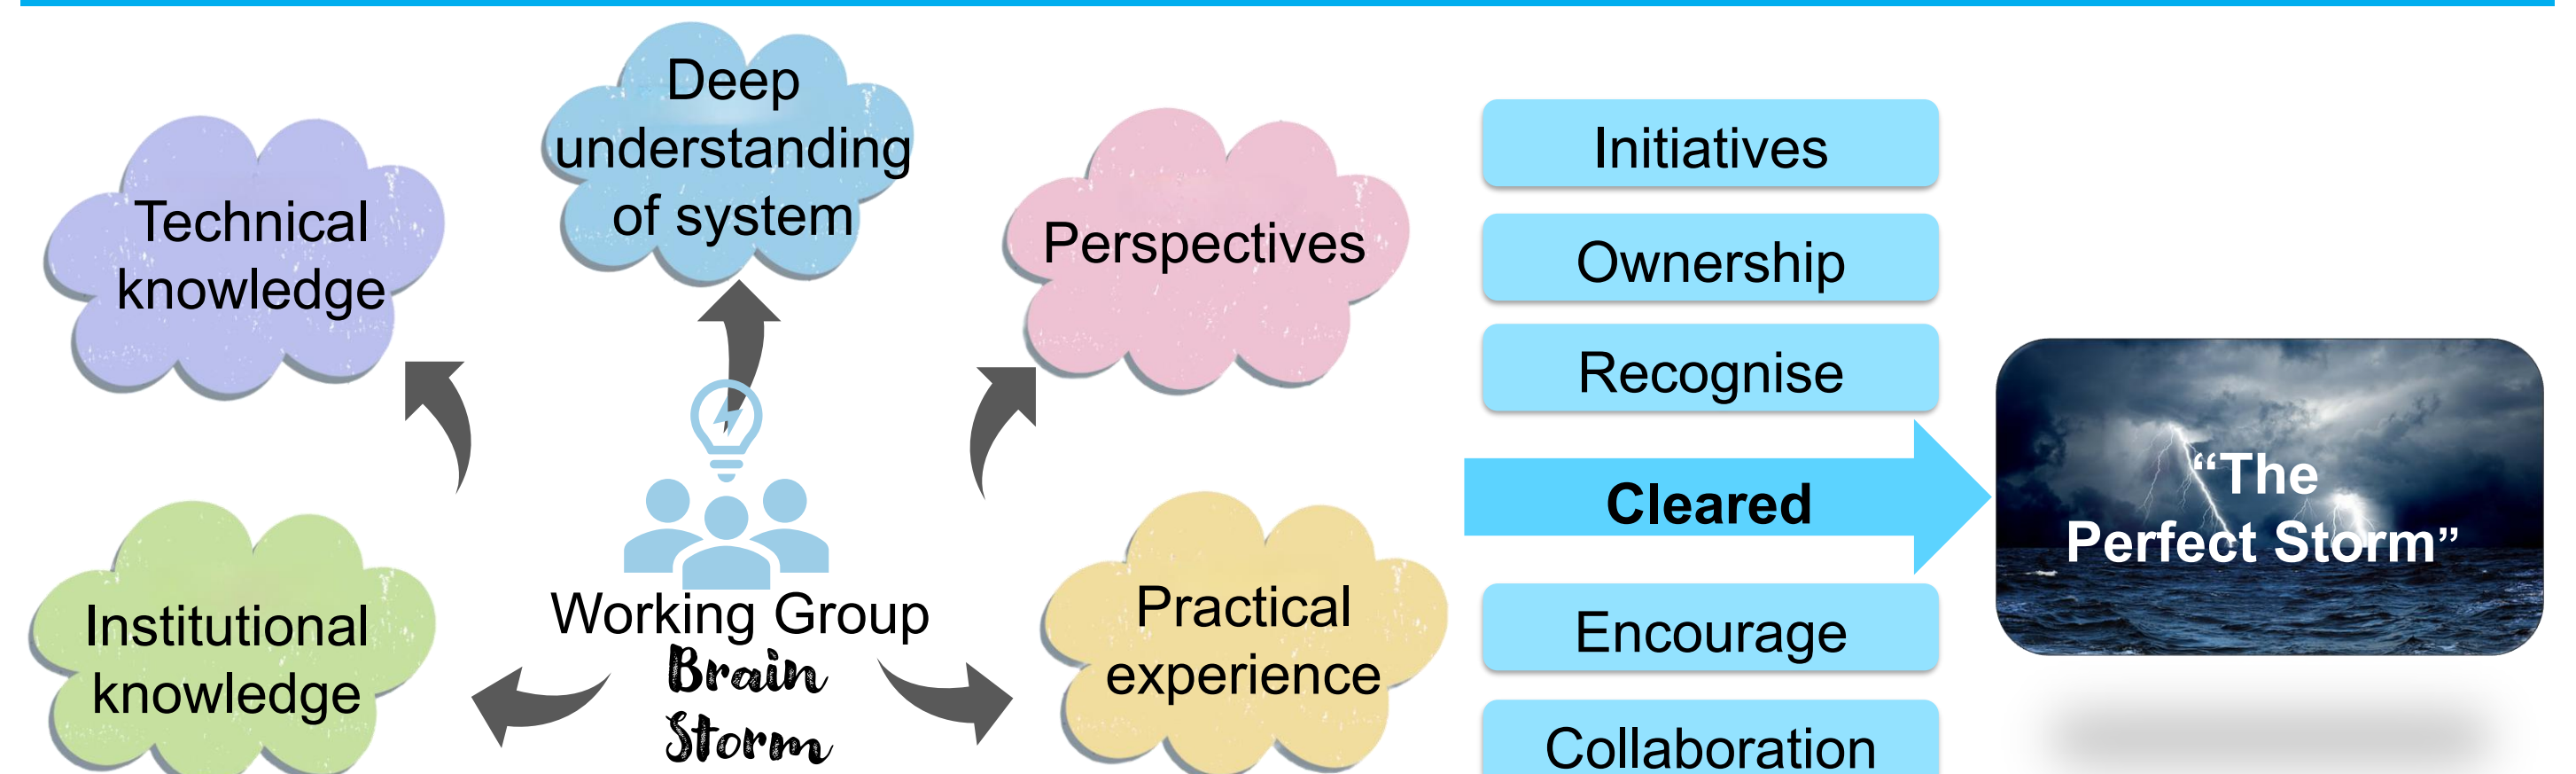
CONCLUSIONS

- Immediate improvement to backwash and filter performance.
 - Backwash pressure reduction from > 75 kPa to 50 kPa
 - Backwash flow from 32.5 m³/min to 36 m³/min
 - Filter run times from 48 hours to 96 hours
 - Reduced filter head losses from > 2m to < 1.5m
- Following 2 filters refurbishment to date have no issues. "best one ever" – Operations Manager

- The existing nozzles were cleaned and reinstated
- Nozzles stems were each checked and trimmed to ensure clearance to the invert of the lateral
- Filter media was replaced with new dual combination to prevent sand migration
- Methodologies established for future works based on the lessons learnt
- QA process established for individual work packages
